Inspection Report

Property Address:

1234 S Main St
Anywhere MN 56789

AmeriSpec Inspection Services

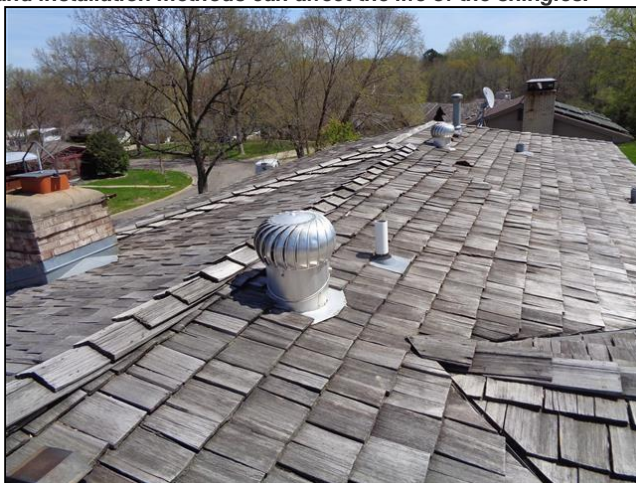
- (1) Wood shakes have an average life expectancy of 25-30 years depending on the grade of shake. Moss is commonly found on this type of roof and regular removal is suggested to prevent premature deterioration.
- (2) Cracked/deteriorated ridge cap shingles noted. We suggest repair/replace as needed to prevent future water entry.

Apparent hail damage was noted. We recommend review by the appropriate insurance carriers and repair by a qualified roofer to the extent necessary to assure that the roof is both serviceable and insurable.

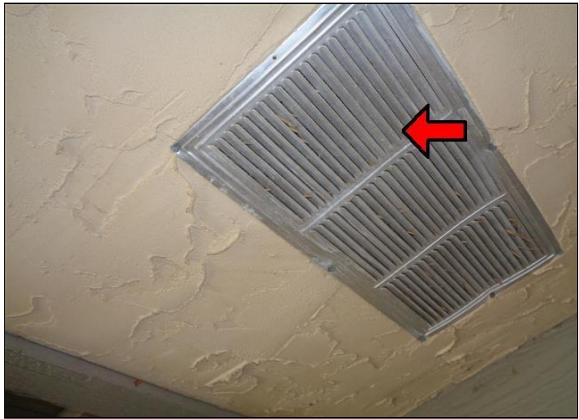
(1) Soffit vents are clogged with dirt, cottonwood and paint. We suggest cleaning to help allow proper attic ventilation.

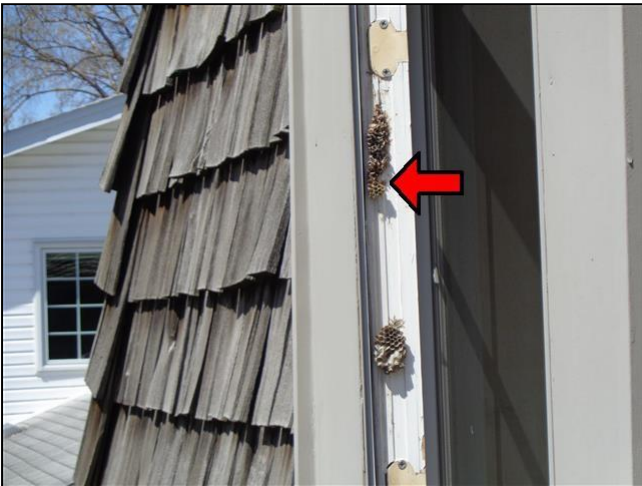
2.5 Windows & Frames

Wasps nests along the upper rear right window frame.

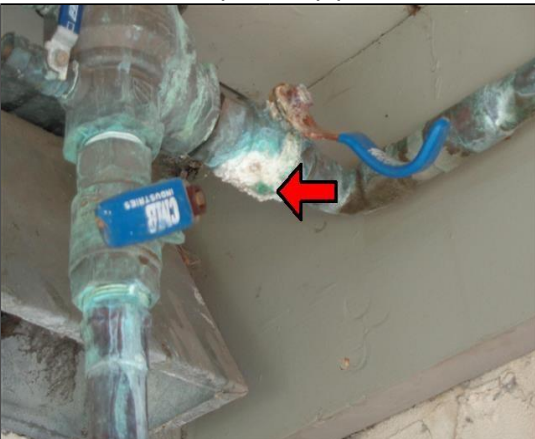
Corrosion on the sprinkler pipe noted. No current leaking noted.

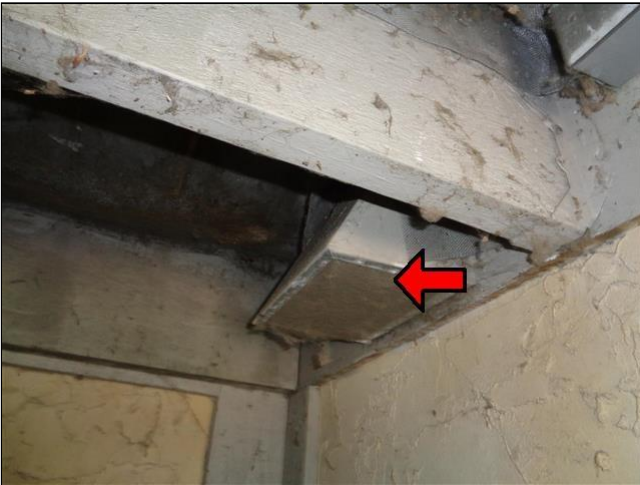
(1) We suggest cleaning fresh air intake now and checking it yearly.

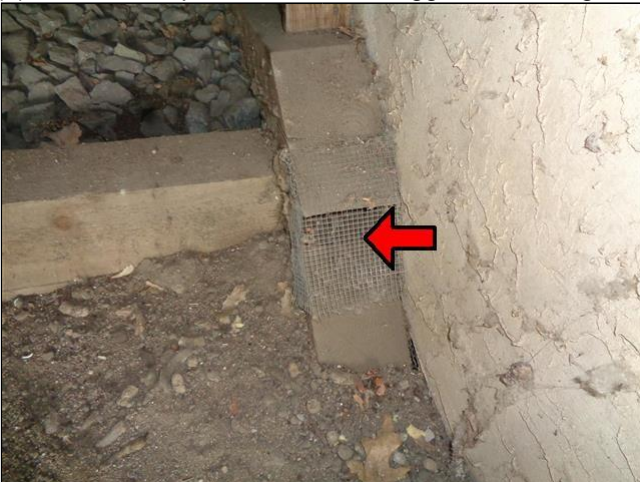
(2) Evidence of pests noted. We suggest reviewing the latest pest control report for more information.

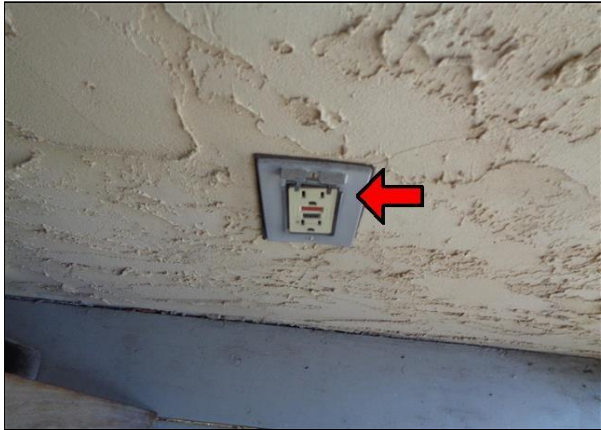
We suggest installing a weatherproof cover on outlet(s) for safety reasons.

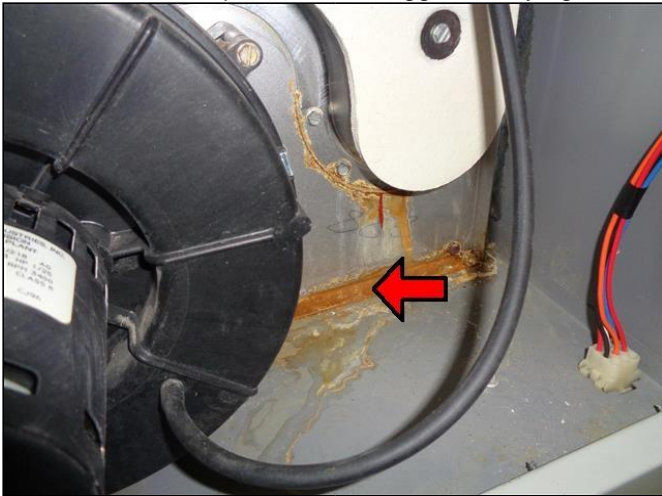
5.0.A Heating Equipment Condition

- (1) Average life expectancy is 20 years. This unit is a 1996 and is near the end of its useful life.
- (2) Rust behind the cover plate and on the casing appears to be from past Furnace/AC condensation leaks. No current water is present. We suggest verifying when and if repairs for this issue were done with the seller.

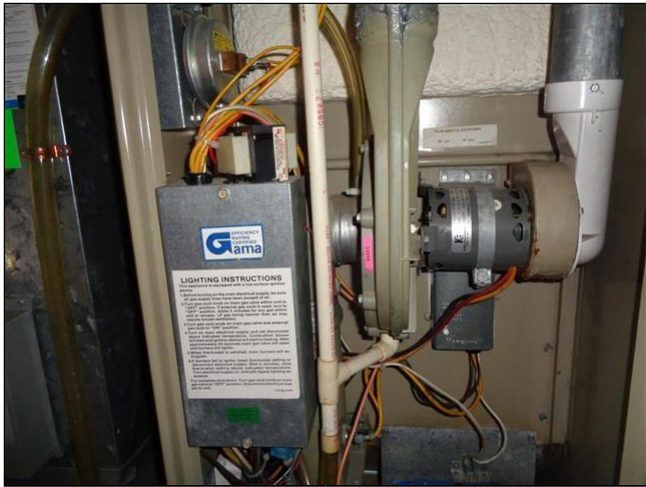
5.0.C Heating Equipment Condition

Average life expectancy is 20 years. This unit is a 1988 and is near the end of its useful life.

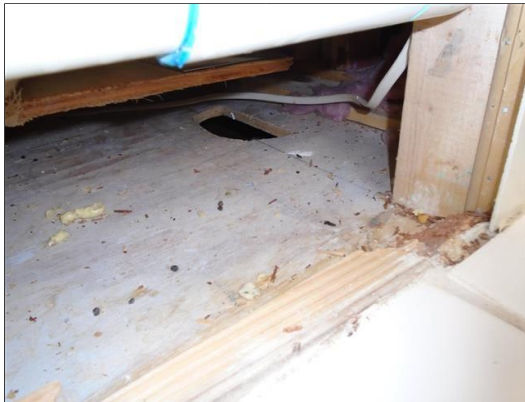
(2) Rodent droppings under tub.

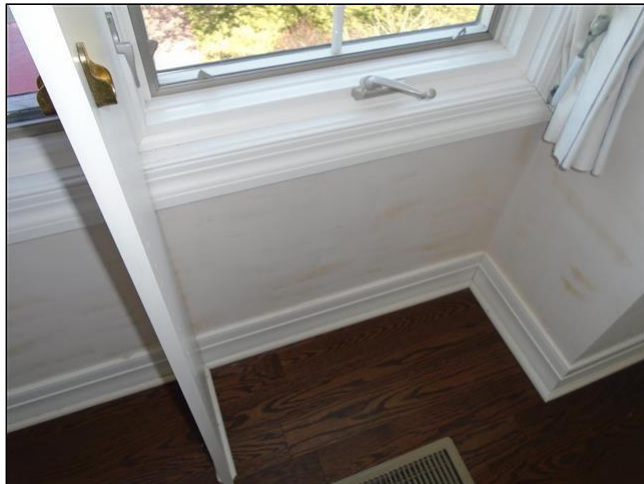
Area of current leaking noted. The area was tested with a moisture meter and high levels were found. Under closet window.

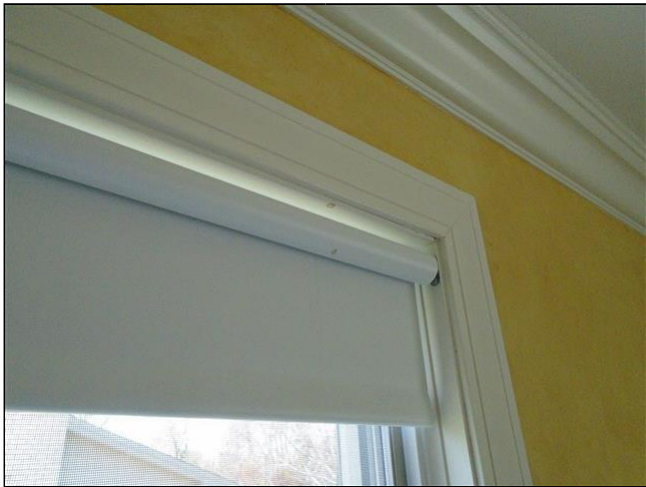
Staining present. The inspector probed stains with a moisture detector, which showed no moisture present at time of inspection. Client is advised to consult seller to determine the source of staining and verify that corrections have been made.
